# **Storm Survey for Tornadoes over Lincoln County on 8/17/2015**

**Two Brief EF1 Tornadoes touched down late Monday afternoon near Genoa. Maximum Wind Speeds with both the Tornadoes were estimated in the 90 to 95 mph range. Both Tornadoes traveled under one tenth of a mile and were less than 50 yards wide.**

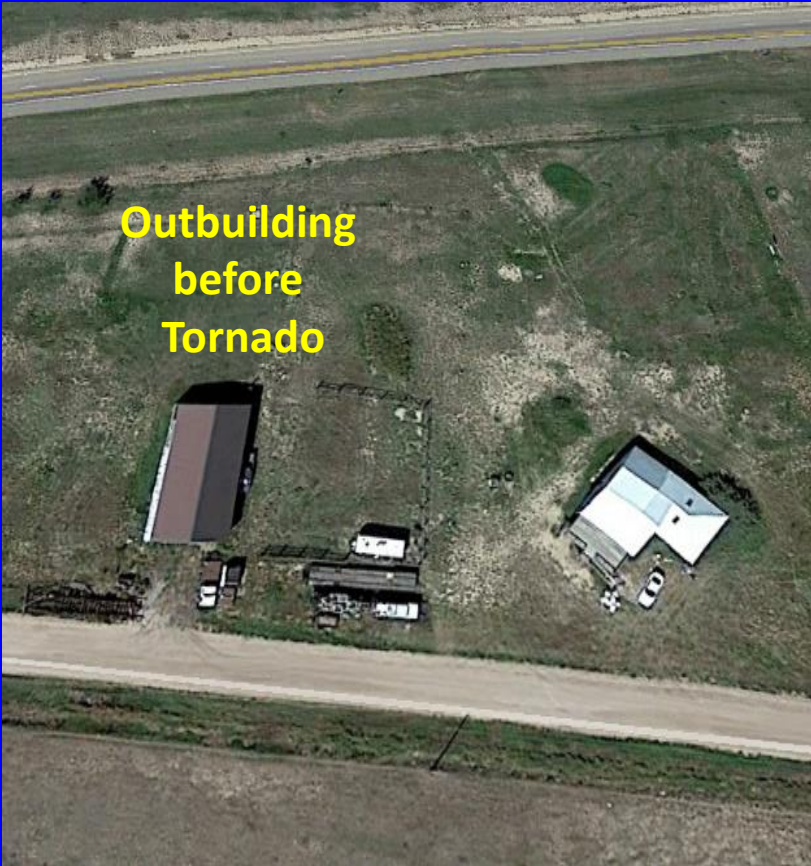
Outbuilding  
before  
Tornado

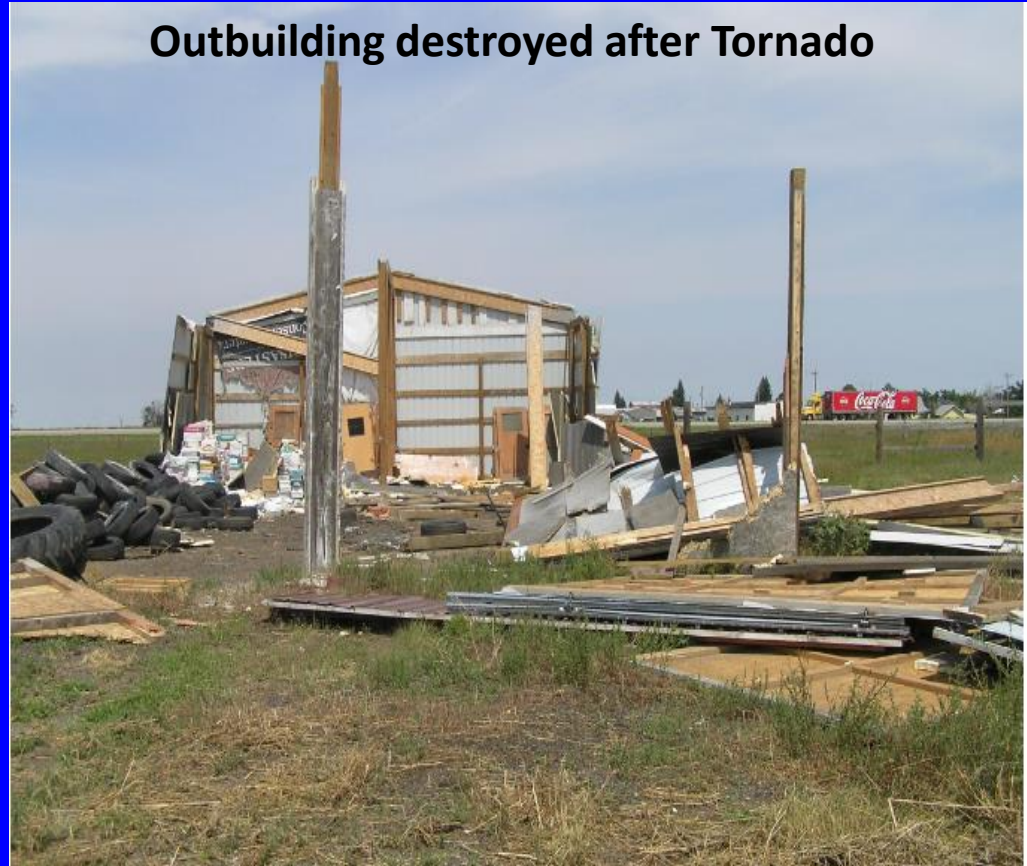
Outbuilding destroyed after Tornado

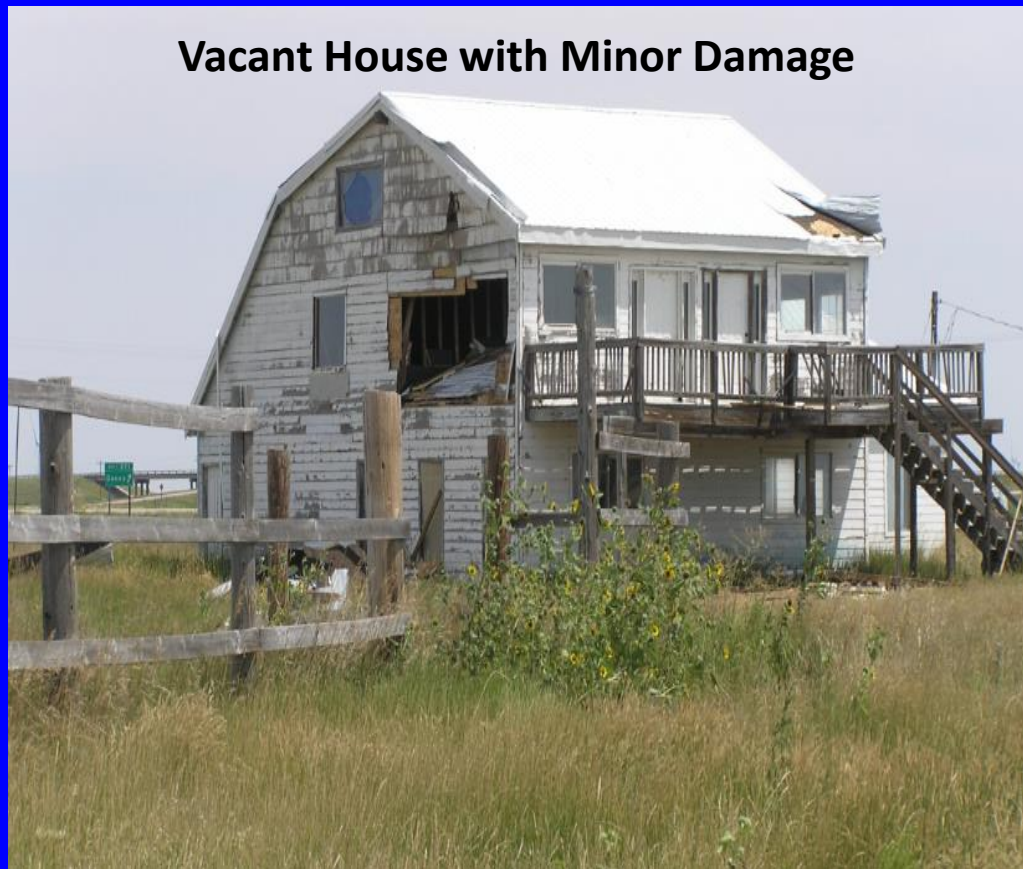
**Vacant House  
next door.**

**Vacant House with Minor Damage**

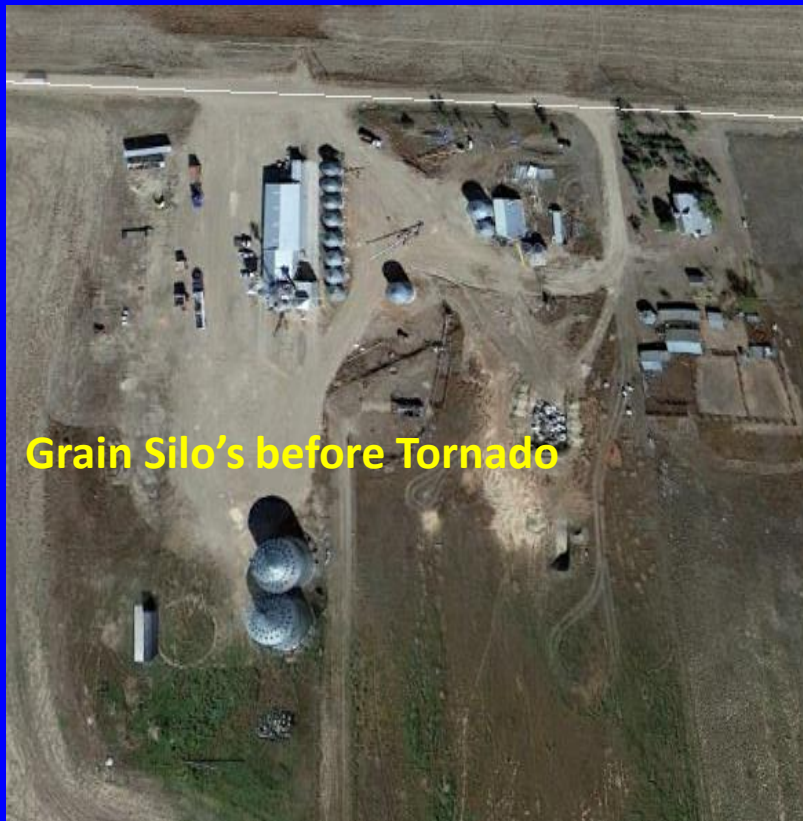
Grain Silo's before Tornado

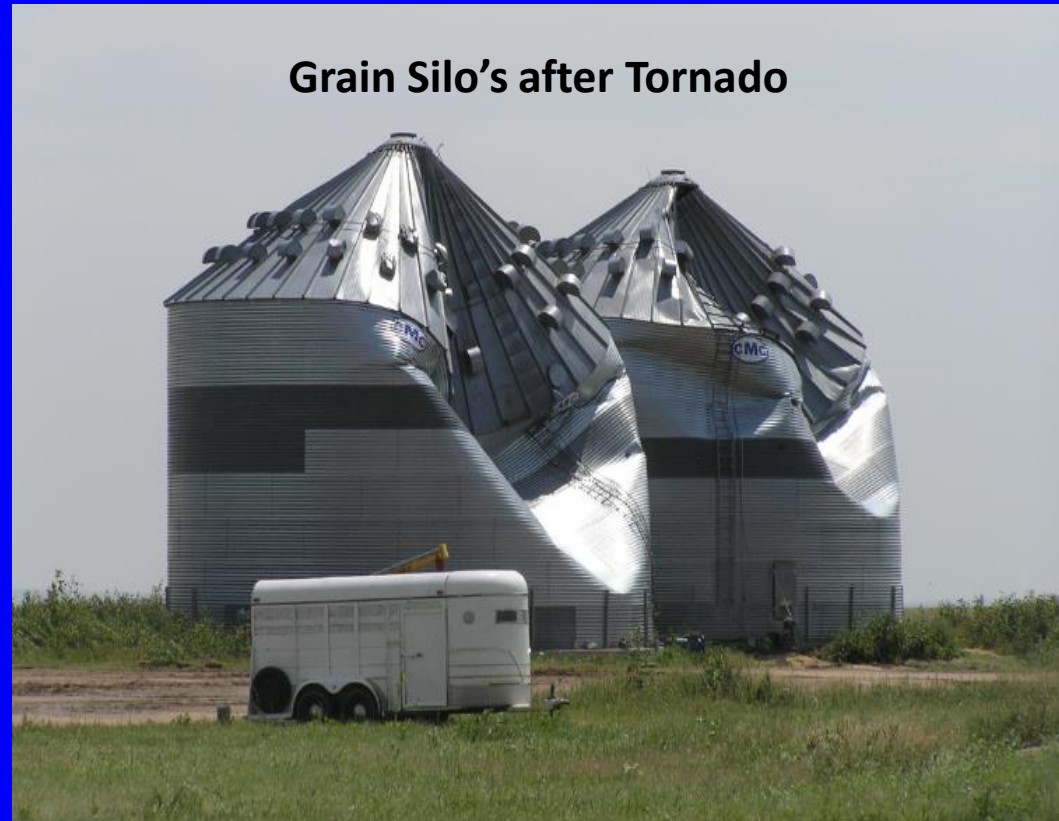
Grain Silo's after Tornado

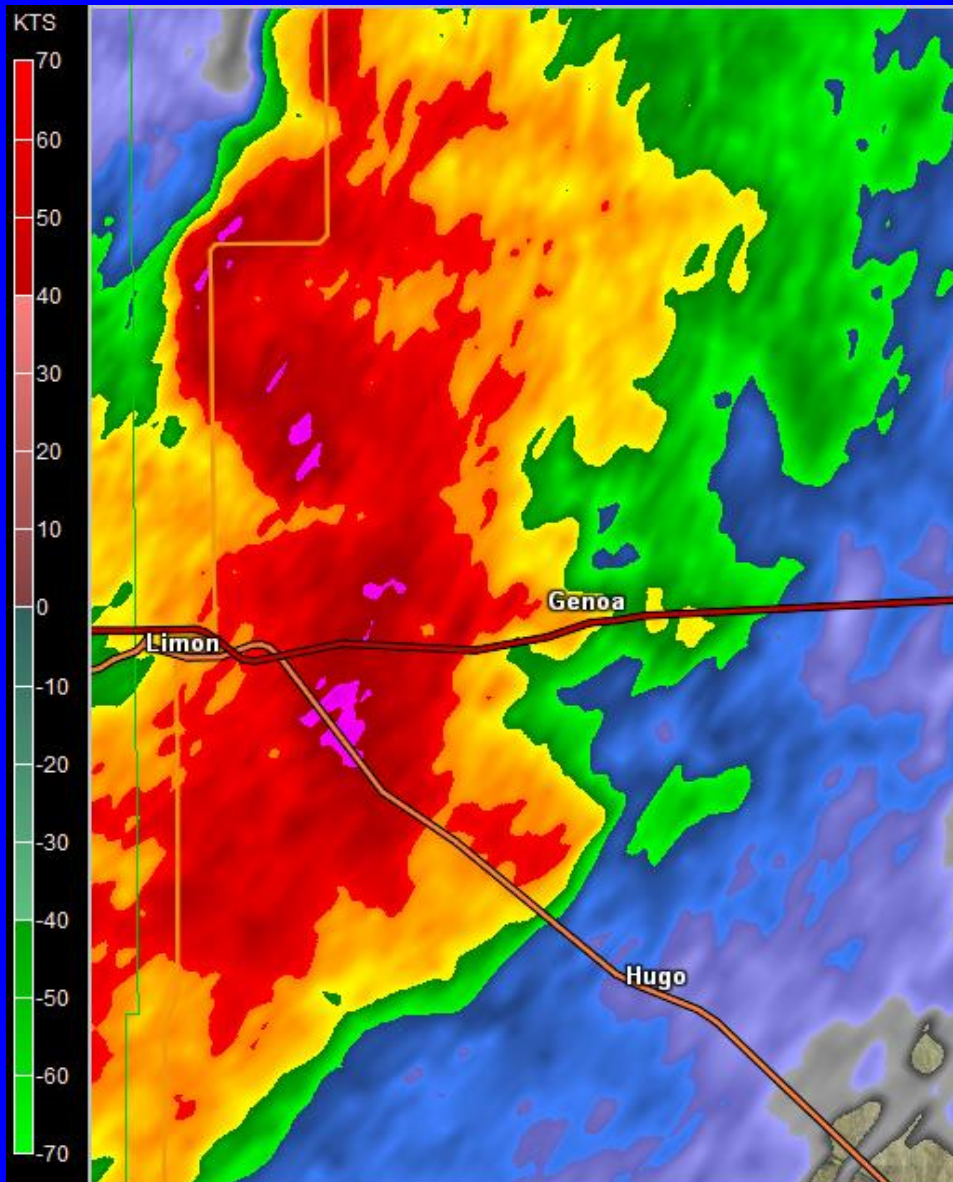
# Radar Picture at 455 pm on August 17, 2015 from KFTG

## Base Reflectivity at 0.5 Degrees

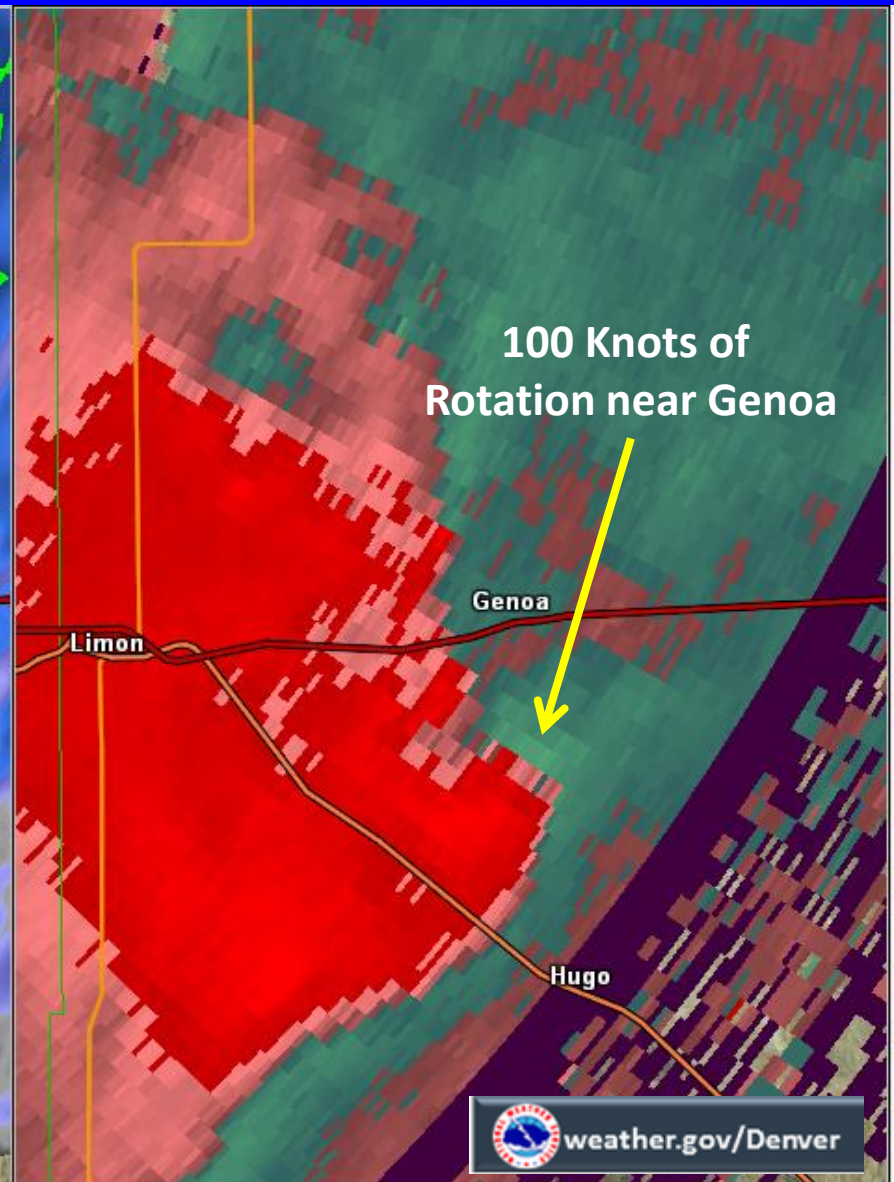
## Storm Relative Velocity at 0.5 Degrees
